# Manhole Inspection Summary

Manhole # S21GG\_001MH

Insp Date: **6/15/07 12:14 PM**

**Location** Address: **1700 BRUCE CT**

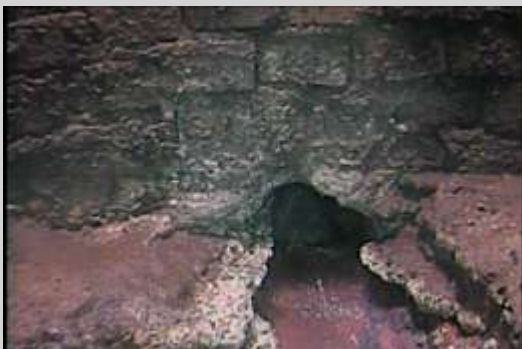
3 O'Clock Inflow

8 in. Circular Gravity Sewer  
Pipe In @ 3 O'Clock

Pipe Height: **8.4** (in.) Rod and Bar (Angled)  
Pipe Material: **Clay** ☐ Pipe Lined  
Invert Depth: **8.99** (ft.) Flow Characteristics: **Slow**  
Deposits: ☒ **None** ☐ Mud ☐ Sludge ☐ Debris ☐ Grease  
Silt Depth: (in.) Deposits Extent:  
Infiltration: **None** Pipe Seal Cond: **Sound**

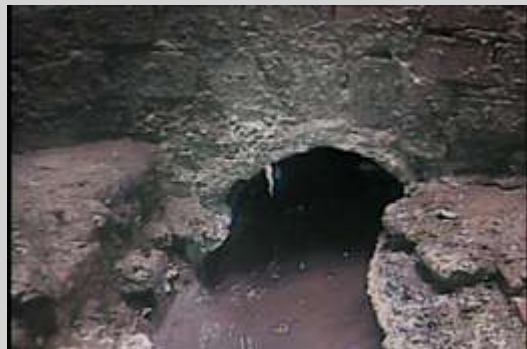
6 O'Clock Inflow

10 in. Circular Gravity Sewer  
Pipe In @ 6 O'Clock

Pipe Height: **9.6** (in.) Rod and Bar (Angled)

Infiltration: **None** Pipe Seal Cond: **Sound**
